FAILURE ANALYSIS OF A SODIUM HEAT PIPE WITH INTEGRAL
LITHIUM FLUORIDE THERMAL ENERGY STORAGE

D.L. Jacobson and P. Soundararajan

MECHANICAL AND AEROSPACE ENGINEERING
ARIZONA STATE UNIVERSITY
TEMPE, ARIZONA 85287

September 1985

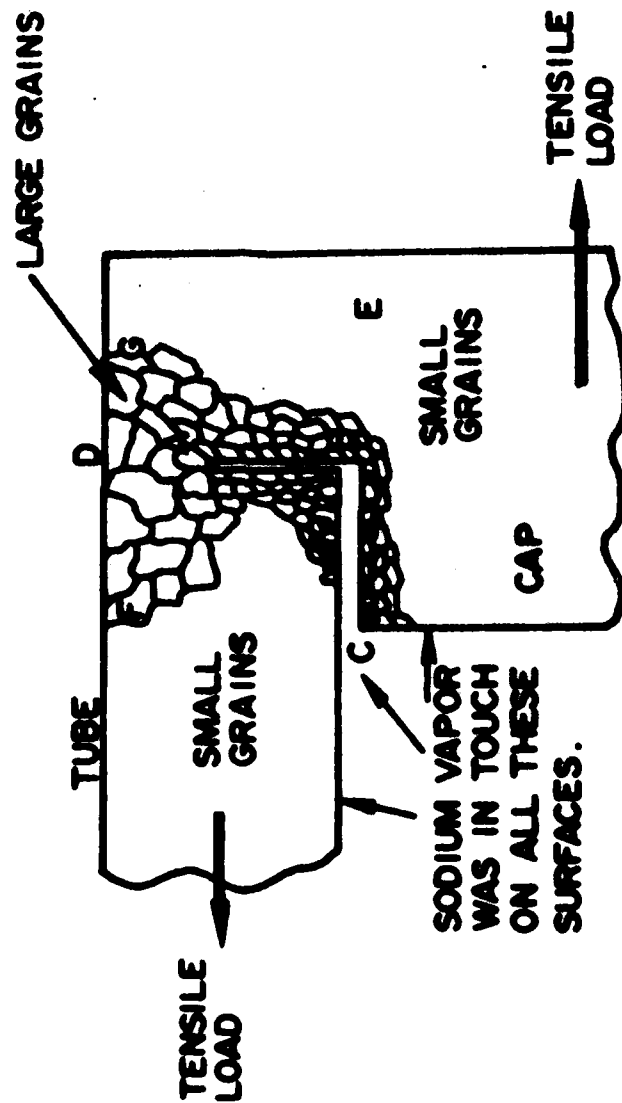
Figure 6a. Representative Sketch of Section 1 Sample.

The best and the most useful data were obtained through the examinations of section 1 samples. They show the geometry of the cap, tube and weld zone. Signs of the initial stages of weld cracking are observable which also most likely existed in the weld on the other end of the heat pipe which was severed at failure. Figure 6a is a sketch of section 1. Figure 6b shows micrographs of section 1 sample No. 1.3 at 200X. The sketch in Fig. 6a serves to highlight five important features: crack length and orientation, gap width, diameter and curvature at the base of the crack, grain discoloration and pitting along grain boundaries, grain size and tensile stressing.

The crack which begins at point A, travels into 49% of the weld depth, A to D, for sample 1.3. It was the longest found. Shorter cracks are also apparent in the section 1 samples along the gap region from B to A with the smallest at point B and growing progressively larger toward A. These cracks tend to run along the grain boundaries. The sketch in Fig. 6a depicts this feature. The gap between tube and cap, from point B to A has been observed in all but one of the samples. It is the unwelded section of contact. This space may have been the result of continuous loading on the cap, but more likely existed at the time of welding. In any case, it allowed liquid sodium, or sodium vapor to easily come into contact with the weld. Also, some widening of the gap at point A (crack base) is apparent. This may be an indication of corrosion. Corrosion is also indicated by the pitting and discoloration (relative darkening) of the grains along the regions C-B and B-A. The weld region extends from A to D (Fig. 6a) and this was made by electron beam.² This type of

General corrosion of the weld surface at point A in Figure 6a was considered but ruled out following the detailed examination of all section 1 samples. These examinations, previously discussed, showed that the thickness of the unfractured weld region was not the same in all samples; it would have been had general corrosion occurred.^{9,10} The general internal surfaces and wick appeared metallographically to have undergone no corrosive attack. Thus, a failure based solely on general corrosion is not likely.

It is felt that the failure could have been avoided with any number of improved weld designs. The weld thickness was found to be as little as 0.01 in. and could have been thinner elsewhere. In general the 321 S.S., sodium system appeared to perform satisfactorily as evidenced by the absence of corrosion, in general, in the heat pipe. It is important though to provide for high purity sodium and to fabricate the heat pipes with exceptionally clean internal surfaces in order to maintain the sodium purity and obtain maximum life time. The thermal energy storage capsules showed no evidence of corrosive attack on the sodium side. The salt-container corrosion analysis will be reported on later.
